# Technical Evaluation of the Gold King Mine Incident

San Juan County, Colorado

October 2015

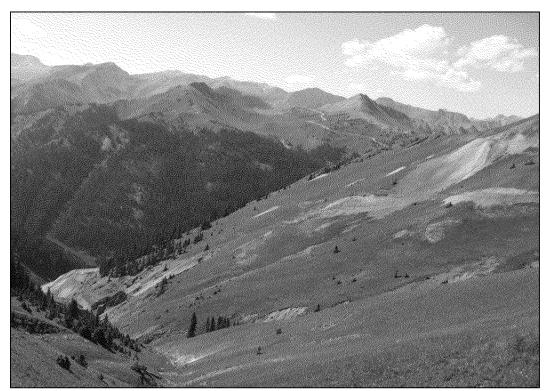
Figure 1.—Photograph of the Gold King Mine looking west. The red arrow points to the location of the mine blowout, which occurred on August 5, 2015.

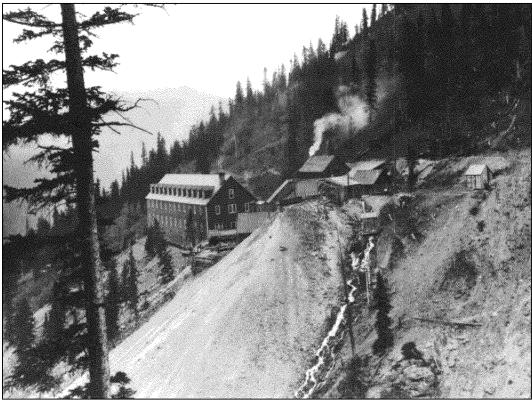
Figure 5.—Historical photograph of the Gold King Mine Level 7 taken prior to the mine closing in 1923. Note the drainage flow down the side of the waste-rock dump.

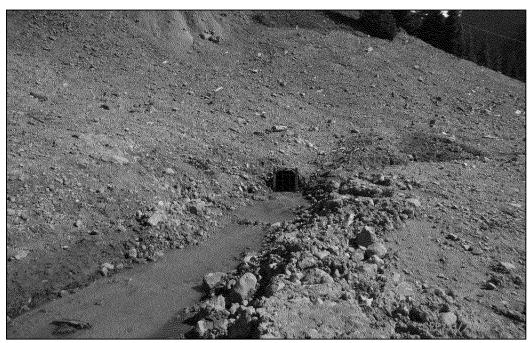
Figure 7.—Photograph showing the seepage outflow from the drain pipe at the American Tunnel at Gladstone, Colorado, as it appeared on September 3, 2015, with about 100 gpm of acid water flowing out.

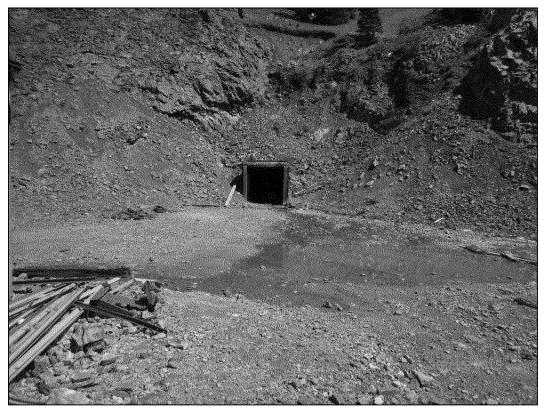
Figure 10.—Photograph showing seepage from the Mogul Mine on September 15, 2015. This mine has hydraulic bulkheads to limit the outflow of water from the Sunnyside Mine.

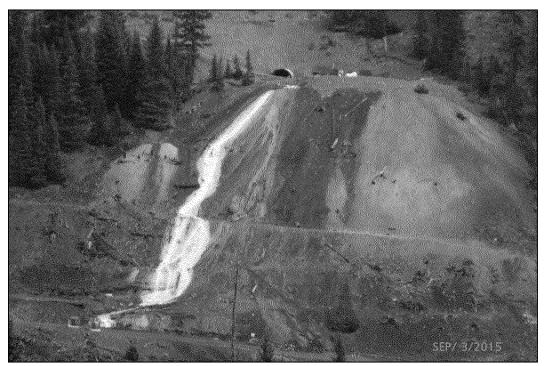
Figure 11.—Photograph showing acid drainage flowing out of the Red and Bonita Mine on September 3, 2015.

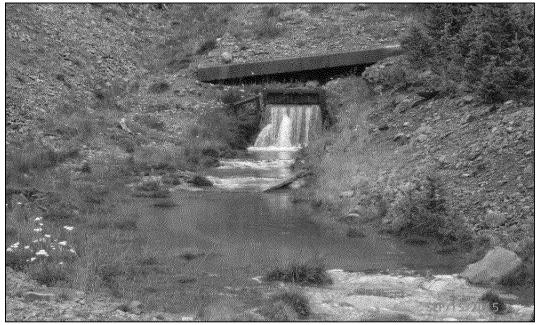
Figure 12.—Photograph taken on September 15, 2015, of drainage from the Silver Ledge Mine, which is located south of the Gold King Mine.

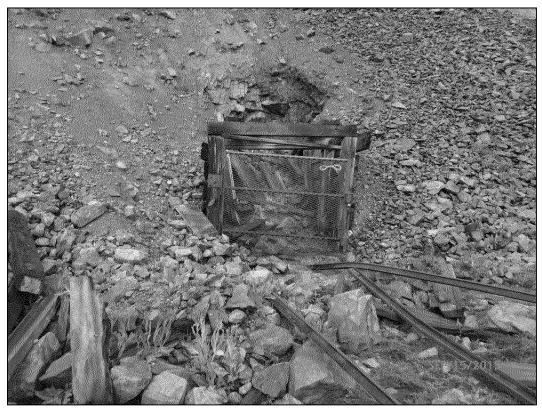
Figure 13. Photograph taken on September 15, 2015, showing acid seepage from the Blackhawk Mine located south of the Gold King Mine.

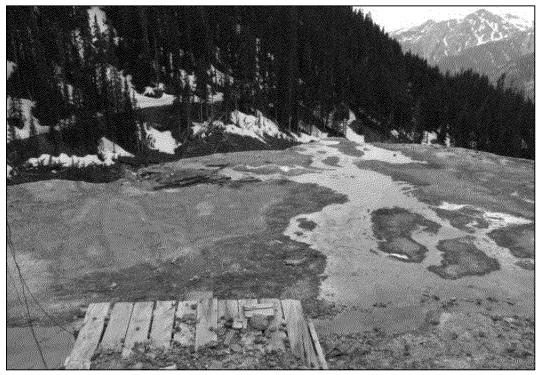
Figure 14.—Photograph showing adit seepage infiltrating into the Gold King Mine Level 7 waste-rock dump in 2007 (from DRMS project files).

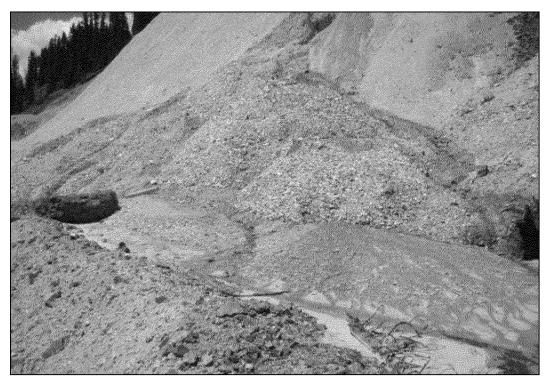
Figure 15.—Photograph showing deposition of landslide material in 2007 blocking a portion of the access road near the base of the waste-rock dump (from DRMS project files).

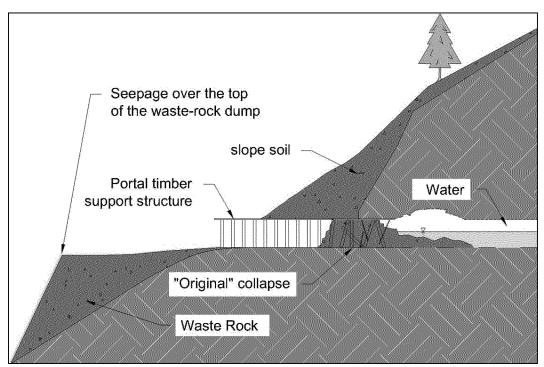
Figure 16.—Cross-section showing the condition of the Gold King Mine Level 7 New Adit in 2007 (not to scale). This shows the water level assumed by DRMS, but it may have been full of water at this time, as was later discovered.

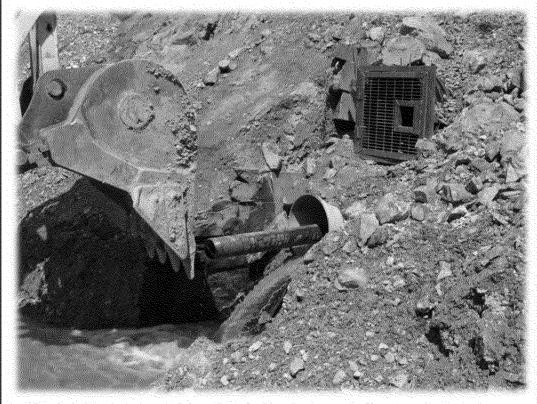
Gold King Level 7 Old Portal with well-point installed through the drain pipe. This portal may be re-opened in a future project to help stabilize the mine drainous and present future increases in mine word, head.

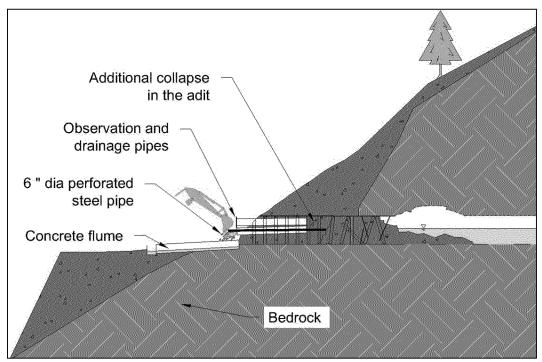
The DRMS stated in the project summary, "A future project at the site may attempt to cooperatively open the Level 7 Old Portal in an effort to alleviate the potential for an unstable increase in mine pool head within the Gold King workings." Essentially, the closure did not provide adequate drainage and had the potential to blowout.

Figure 21.—Cross-section showing the installation of pipes by DRMS at the Gold King Mine Level 7 New Adit in 2009 (water level as assumed by DRMS) (not to scale).

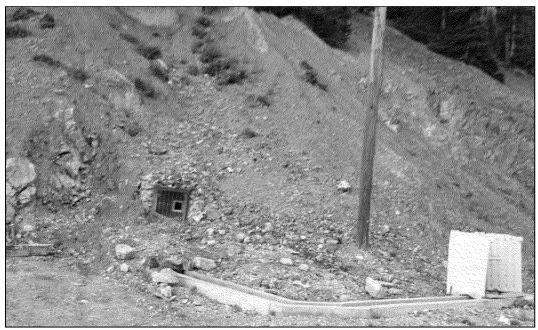
Figure 22.—Photograph showing the condition of the Gold King Level 7 New Adit portal on August 27, 2014, prior to any EPA modifications. Soil and rock debris have migrated downslope and covered a portion of the drain installed in 2009 (photograph from EPA project files).

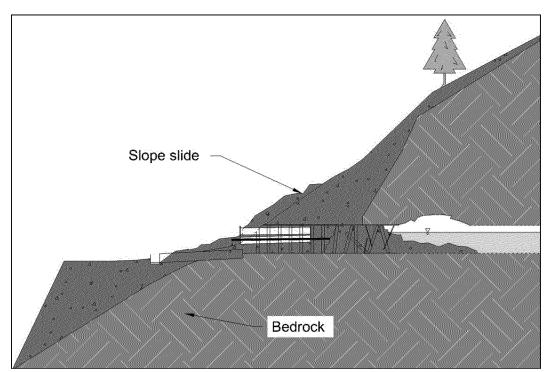
Figure 23.—Cross-section showing the condition of the Gold King Mine Level 7 New Adit in 2014 (water level as assumed by EPA and DRMS), more rock and soil had come down off the slope and were partially blocking the drain, which indicates a lack of maintenance (not to scale).

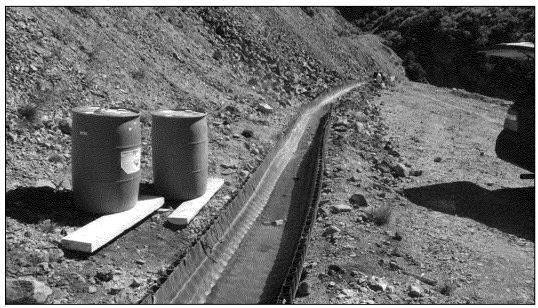
Figure 24.—Photograph showing seepage flow in the half-pipe channel at the Gold King Mine Level 7 New Adit area on September 11, 2014. Flow of approximately 12.6 gpm was recorded (photograph from EPA project files).

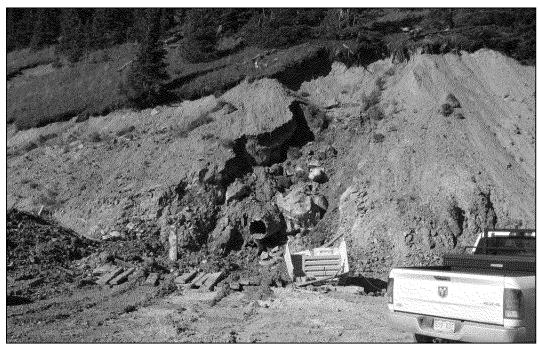
On September 11, 2014, excavations were performed to remove the metal grating and portions of the two pipes installed in 2009. As the excavation progressed down through the fill, seepage appeared (figures 25 through 27). The work stopped when EPA, DRMS, and others observed that in addition to the seepage from the base of the fill, additional seepage was now flowing from higher up on the face of the backfill. Because the excavation had a lip, the seepage ponded at a level equivalent in elevation to about 4 feet below the top of the adit. It was reportedly concluded by those onsite that there was 6 feet of water impounded in the mine (Way, 2014b). A small settling pond was installed at the base of the waste-rock dump to remove sediment from the mine water. The pond was not large enough to treat and settle what was believed to be 6 feet of impounded water. Therefore, the project was put on hold until the following year.

Figure 25.—Photograph showing excavation of the Gold King Mine New Adit portal on September 11, 2014. The metal grating and portions of the upper corrugated HDPE pipe and the lower solid-wall drain pipe have been removed (photograph from EPA project files).

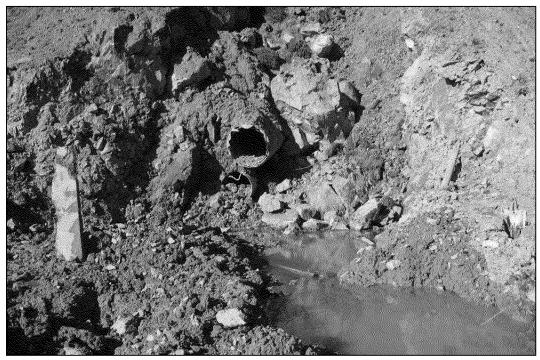
Figure 26.—Photograph showing the excavation of the Gold King Mine New Adit portal on September 11, 2014, taken shortly after the photograph in figure 23 (photograph from EPA project files).

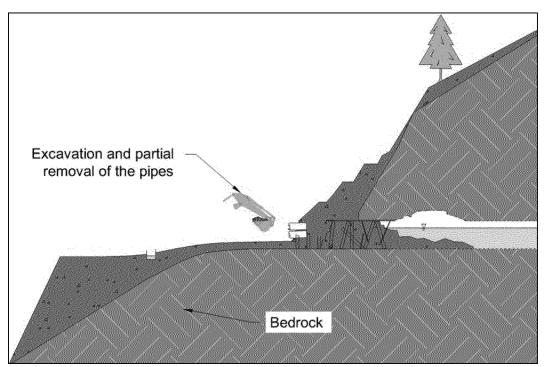
Figure 27.—Cross-section showing the condition of the Gold King Mine New Adit in 2014 (water level as assumed by EPA and DRMS) after the excavation shown in figure 23 was complete (not to scale).

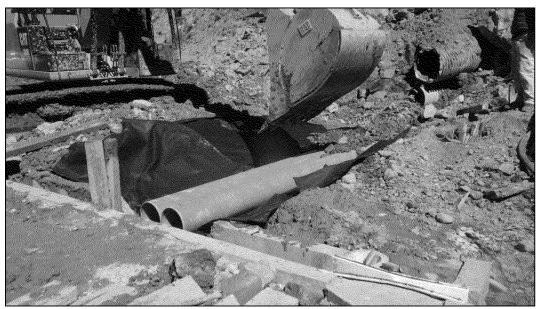
Because they had torn out most of the drain and observation pipes installed by DRMS in 2009, EPA decided to install two new drain pipes surrounded by gravel and a geotextile as a temporary measure. The new pipes were laid at a different angle than the 2009 installation. The side of the concrete trough had to be cut open to accommodate the new drain pipes (figure 28).

Figure 28.—Photograph taken on September 11, 2014, showing the installation of two new 2-foot-diameter drainage pipes. An entrance slot has been cut into the concrete trough for the pipes to discharge into (photograph from EPA project files).

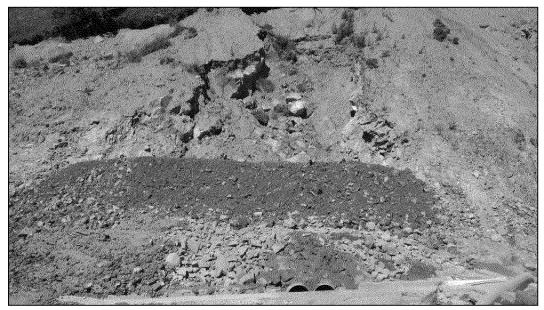
Figure 29.—Gold King Mine Level 7 New Adit as it appeared on September 12, 2014, when EPA completed placing backfill over the two new drain pipes. Note that a steep slope was left in place in the mountainside above the drain pipe installation (photograph from EPA project files).

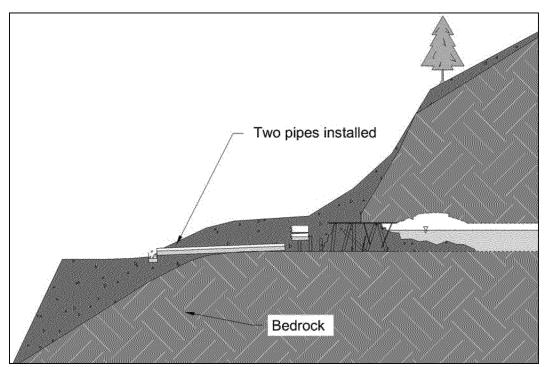
The pipes were covered with gravel. The geotextile was wrapped around the gravel to prevent infiltration of backfill to maintain a pervious zone around the pipes. The geotextile was then covered with backfill. In order to prevent erosion of the backfill soil into the concrete trough, a layer of fast setting concrete was placed over the backfill slope adjacent to the trough (figures 29 and 30).

Figure 30.—Cross-section showing the condition of the Gold King Mine Level 7 New Adit in 2014 (water level as assumed by EPA and DRMS), after the installation of the two drain pipes and backfill cover (not to scale).

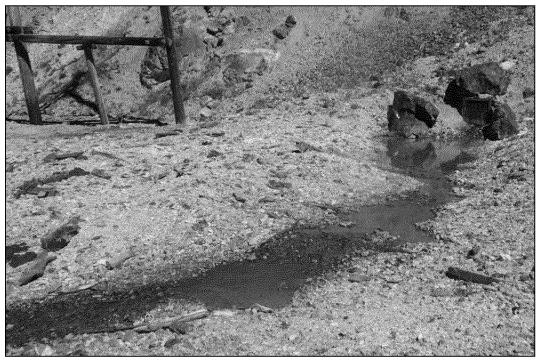
Figure 31.—Gold King Mine Level 7 OLD Adit (upper right) showing a small amount of seepage flow on September 11, 2014. At the portal, the floor of the old adit is approximately 2 feet higher than the floor of the old adit portal (photograph from EPA project files).

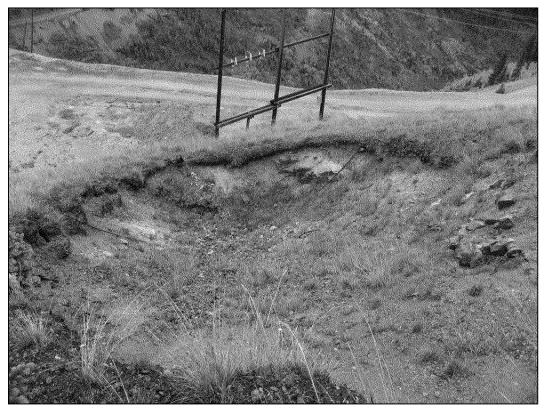
Figure 32.—Photograph taken on September 22, 2014, looking downhill at the subsidence pit located above the Gold King Mine Level 7 Old Adit.

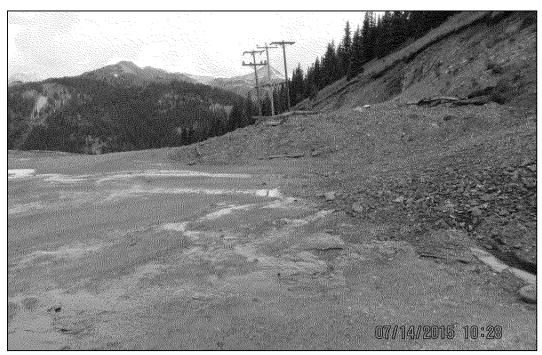
Figure 33.—Photograph showing the condition of the Gold King Mine Level 7 Old Adit portal area on July 14, 2015. Note that more soil and rock had slid from the slope area and had buried a portion of the concrete diversion channel including the ends of the two drain pipes (photograph from EPA project files).

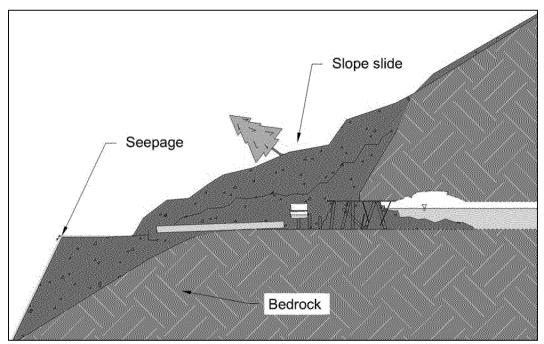
Figure 34.—Cross-section showing the condition of the Gold King Mine Old Adit on July 14, 2015 (water level as assumed by EPA and DRMS), when EPA returned to the site to begin work. More rock and soil and a tree had slid down onto the drains, and seepage was again saturating part of the waste-rock dump (not to scale).

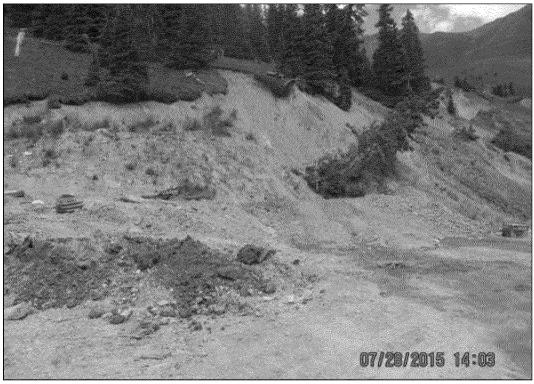
Figure 35.—Photograph showing the condition of the Gold King Mine Level 7 New Adit portal area on July 28, 2015. Note the soil and a tree that has slid downslope onto the portal area; at this time the seepage had been returned to the concrete trough, and the dump was drying out (photograph from EPA project files).

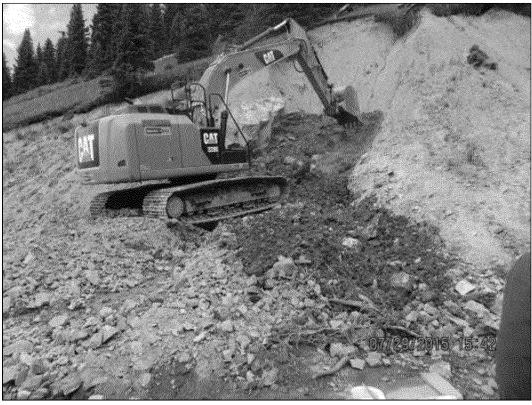
On July 29, 2015, some of the debris that had sluffed down over the winter was excavated from the portal area, and the ends of the pipes were exposed (figure 36). On July 31, 2015, work was begun putting together a manifold piping system that could be used to provide water filtration for the anticipated pump-down of the Gold King Mine.

Figure 36.—Photograph taken on July 29, 2015, showing initial excavation work at the Gold King Mine Level 7 New Adit that was performed to remove the additional accumulation of debris from the eroding slope above the adit (photograph from EPA project files).

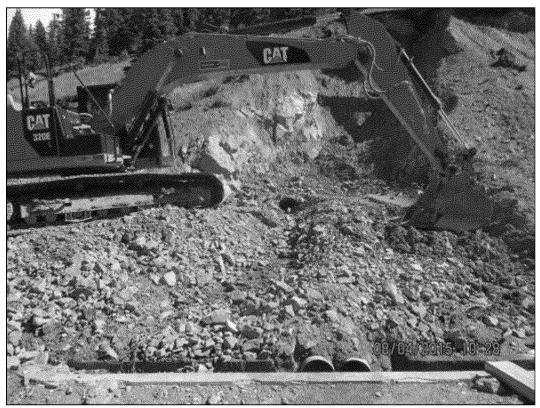
On August 4, 2015, a representative from DRMS was onsite and viewed conditions at the adit. EPA began excavation to examine conditions close to the mine opening similar to what had been done in 2014 (figure 37).

Figure 37.—Photograph showing additional excavation at the Gold King Mine Level 7 New Adit at 10:28 a.m. August 4, 2015 (photograph from EPA project files).

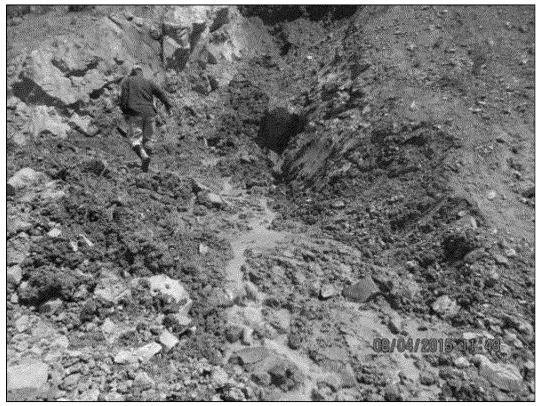
Figure 38.—Photograph showing seepage flow from the excavation at the Gold King Mine new portal at 11:48 a.m. on August 4, 2015. The flow is emerging approximately 5 to 6 feet above the floor of the adit (photograph from EPA project files).

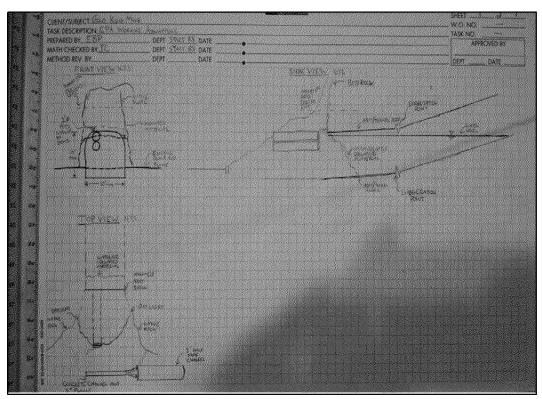
Figure 39 shows a sketch of the plan to open the Gold King Mine Level 7 New Adit portal. To provide a margin of safety, the plan assumes the water was more than 5 feet deep on the upstream side of the blockage, but still below the adit roof.

Figure 39.—Photograph showing the sketch used by EPA to illustrate the conditions at the Gold King Mine Level 7 New Adit portal (photograph from EPA project files).

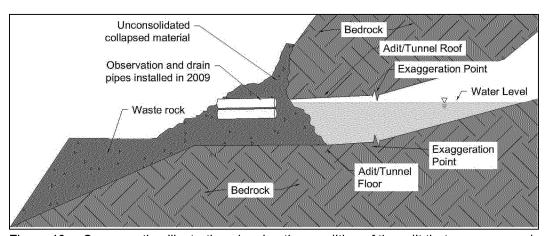
Figure 40.—Cross-section illustration showing the condition of the adit that was assumed by the EPA OSC and the abandoned mine experts from DRMS for use in planning to open the adit (not to scale). The "exaggeration point" means the right side of the drawing has an exaggerated vertical scale in order to show the 1% uphill slope of the adit. If drawn without exaggeration, the uphill slope of the adit would not be obvious on the drawing.

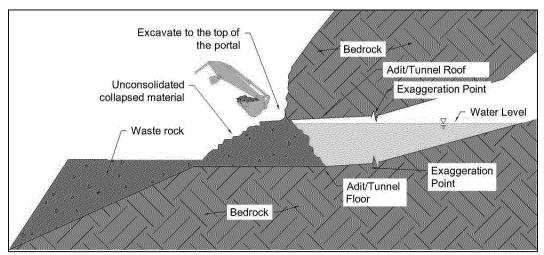
A key aspect of their plan was to only excavate fill lying above the assumed top of the water inside the adit. This method would leave in place the fill holding back the water (figure 41). The next step would push a steel pipe called a "stinger" through the top of the fill to gain access to the mine pool (figures 42 and 43).

Figure 41.—Cross-section illustration showing step 1, the initial excavation to remove the drain pipes and backfill and then carefully excavate the collapsed material to expose the bedrock in the slope above the adit (not to scale).

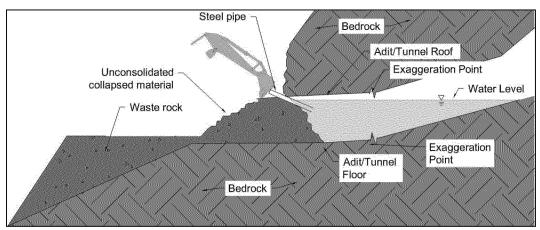
Figure 42.—Cross-section illustration showing step 2 of the plan (not to scale). With the bedrock above the crown of the adit exposed as a guide, a steel pipe called a "stinger" is positioned and pushed into the fill using the bucket of the hydraulic excavator.

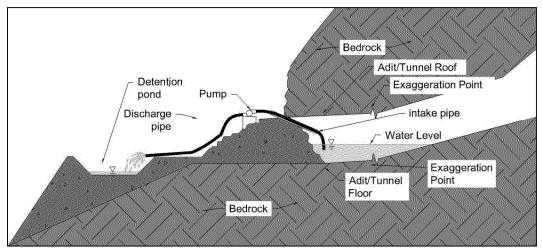
Figure 43.—Cross-section illustration showing step 3 of the plan (not to scale). With the steel pipe fully inserted, contact is made with the water impounded inside the mine.

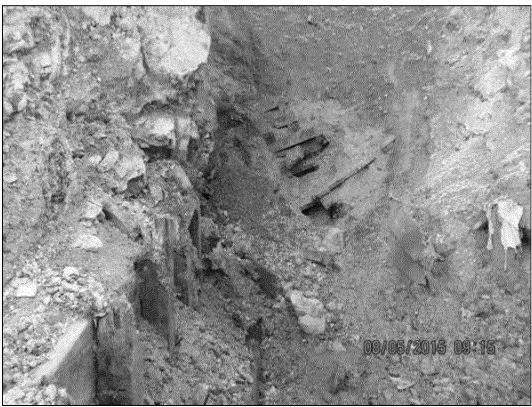
Figure 46.—Photograph taken at 9:15 a.m. August 5, 2015, showing the Gold King Mine Level 7 New Adit excavation uncovering mine timbers and lagging (photograph from EPA project files). Minor seepage is visible just to the left of the date stamp where a small puddle has formed. Note the soil in the upper end of the excavation above the timber lagging.

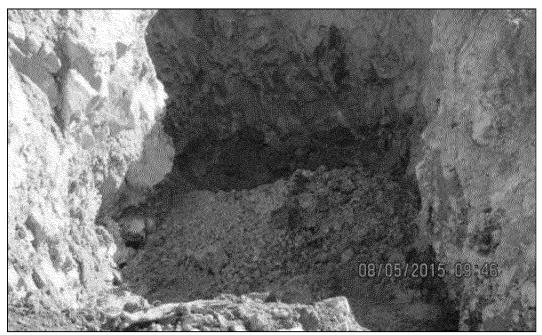
Figure 47.—Photograph taken at 9:46 a.m. August 5, 2015, showing that the loose soil from the upper end of the excavation had been removed exposing fractured and crumbly rock (photograph from EPA project files). The fill derived from the excavation had now covered the timbers, lagging, and seep visible in the previous photograph (figure 46). This indicates that the bottom of the excavation was about 10 feet above the level of the floor of the adit; this corroborates reports that they were digging high, trying to stay above the assumed water level in the adit.

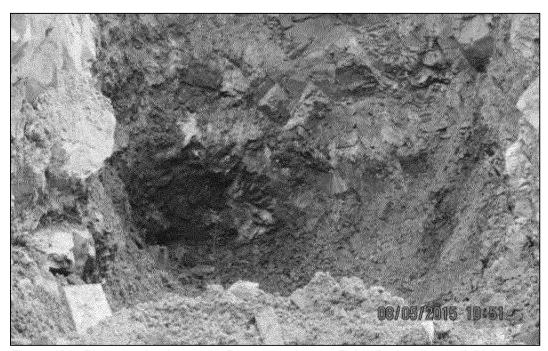
Figure 48.—Photograph taken at 10:51 a.m. on August 5, 2015, showing the initial spurt of clear water (photograph from EPA project files). The center of this photograph is shown enlarged in figure 49.

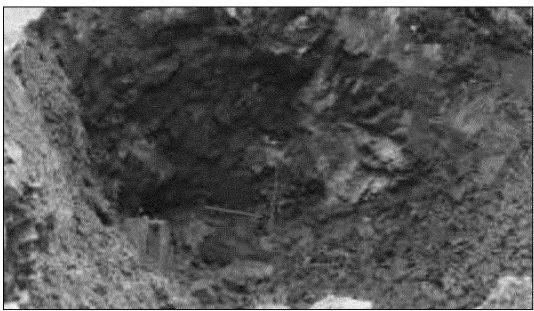
As the excavator continued to dig on August 5, 2015, the operator reported hitting a "spring." He stopped, they removed the excavator, and the EPA OSC went up to look at the conditions. Within moments, the "spring" began spurting upward 1.5 to 2 feet into the air (figures 48 through 50).

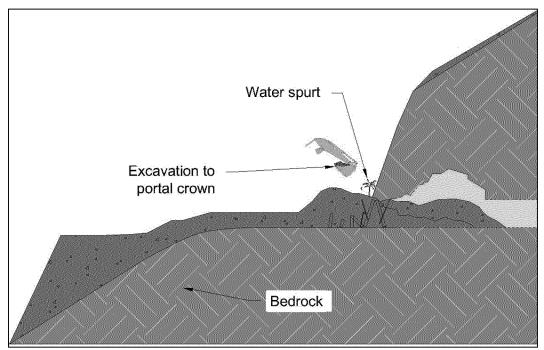
Figure 50.—Cross-section showing BOR's interpretation of the conditions immediately before the blowout as the spurt of water appeared indicating the adit was full and under pressure (not to scale).

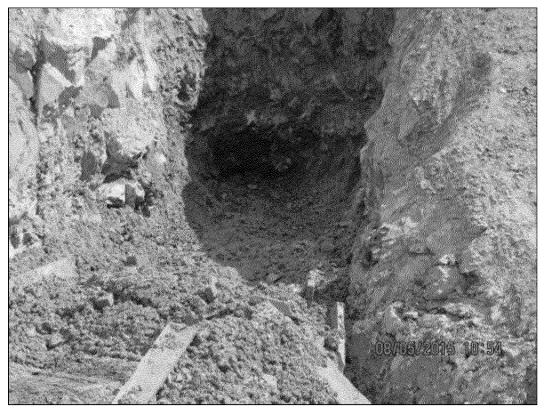
Figure 51.—Photograph of the uncontrolled flow taken at 10:54 a.m. on August 5, 2015. In 3 minutes, the flow progressed from a vertical spurt of water to the flow erosion evident in this photograph. The EPA OSC then made a decision to evacuate the portal opening to safeguard personnel onsite. A few moments later the flow erupted in an uncontrolled release (photograph from EPA project files).

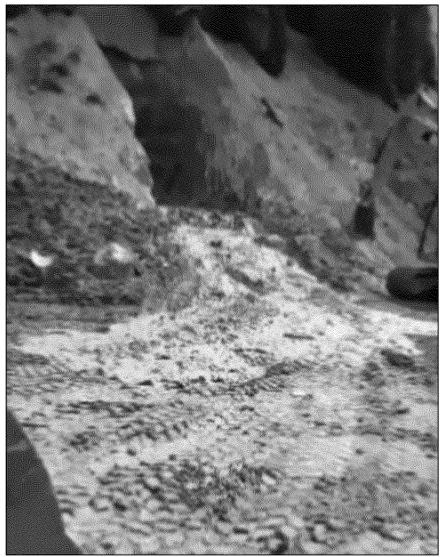
Figure 52.—Photograph showing the initial blowout from the adit. At this point, the flow is surging up over the backfill that was present in the portal area (still frame extracted from a video taken on August 5, 2015, at approximately 10:55 a.m.).

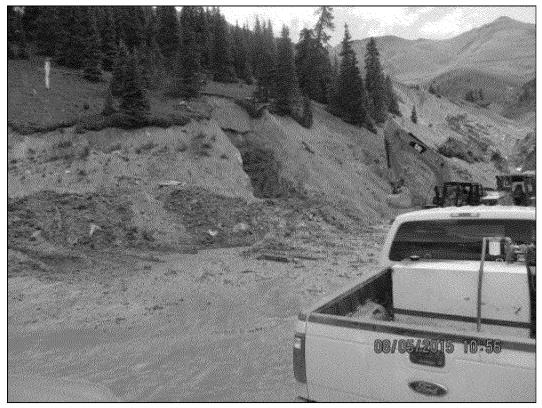
Figure 53.—Photograph showing the blowout at 10:56 a.m. on August 5, 2015 (photograph from EPA project files).

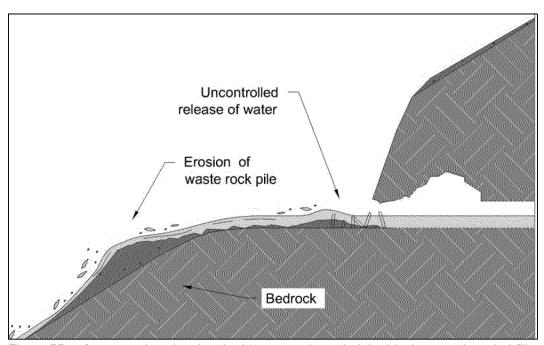
Figure 55.—Cross-section showing the blowout as it eroded the blockage and eroded fill from the waste-rock dump (not to scale).

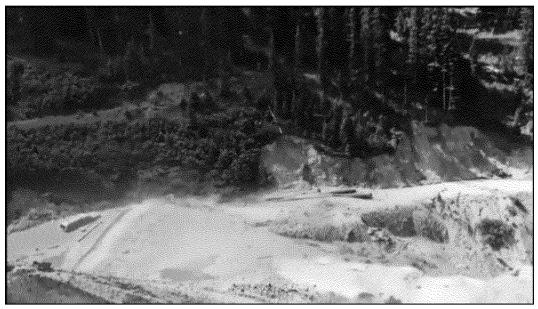
Figure 56.—Photograph showing at left, the inundation of a vehicle parked near the base of the waste-rock dump, and on the right water overwhelming the access road and cascading down into the North Fork of Cement Creek (still frame extracted from a video taken on August 5, 2015, at approximately 10:57 a.m.).

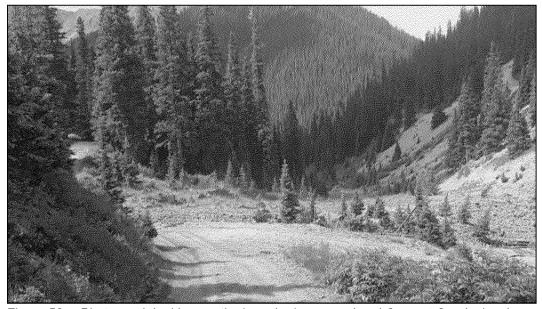
Figure 58.—Photograph looking south along the lower road and Cement Creek showing the blowout flow surging across the lower road and overwhelming Cement Creek (still frame extracted from a video taken on August 5, 2015, at approximately 11:00 a.m.).

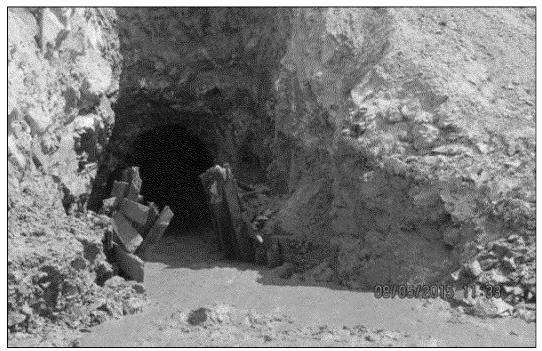
Figure 59.—Photograph showing the condition of the adit at 11:33 a.m., August 5, 2015; the peak flow of the uncontrolled release had passed and the flow rate was decreasing (photograph from EPA project files).

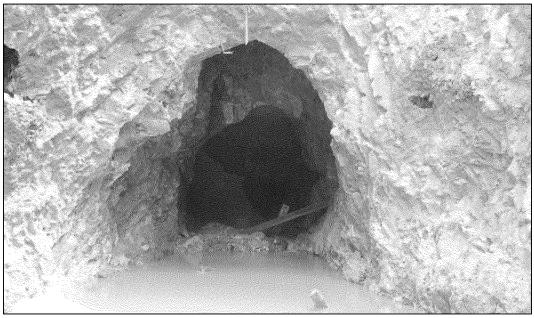
Figure 62.—Photograph showing the Gold King Mine Level 7 New Adit on August 16, 2015, after an excavator was used to reach inside the mine opening and remove the timbers. Note piles of debris from partial roof collapses inside the adit.

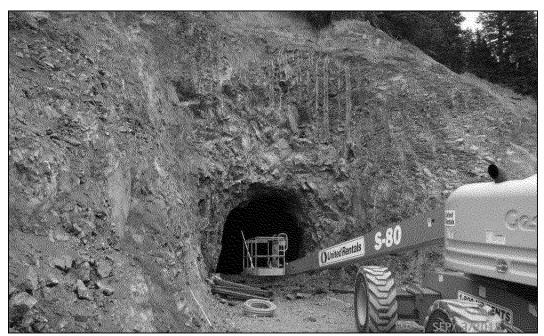
Figure 64.—Photograph showing the adit on September 3, 2015, at the initiation of rock bolting. The rock had been excavated to provide a larger work area. Note the excavator teeth marks left in the rock, an indication that the rock is altered and contains a significant amount of clay.

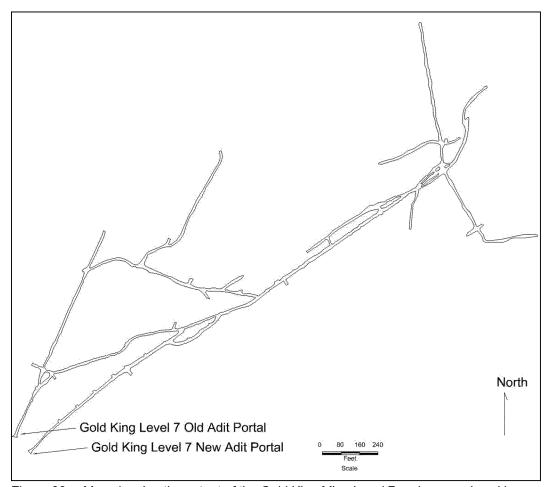
More importantly, because of the gently inclined slope of the new adit to provide drainage, even if the 3 million gallons did not completely fill Level 7 of the mine, it would have completely filled the mine portal area under pressure. The floor of the adit 1,000 feet back in the mine is 10 feet higher than it is at the mine entrance. Even if the water was only 1 foot deep there, the pressure against the portal blockage would have been equivalent to 11 feet of water. The Level 7 adit is estimated to be approximately 2,400 feet long, and therefore it can reasonably be assumed that the water pressure at the portal was significantly higher than that resulting from the water being simply full to the roof at the portal.

Figure 66.—Map showing the extent of the Gold King Mine Level 7 underground workings.

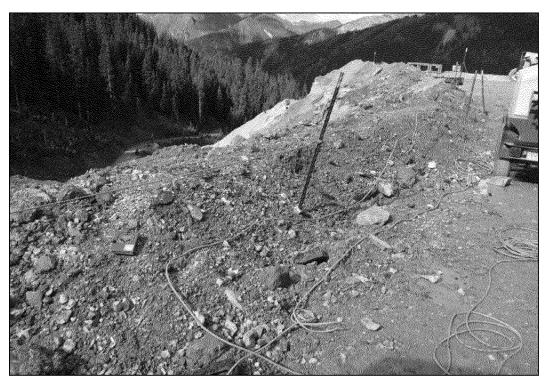
Figure C-1.—Photograph showing the safety berm made of soil that was excavated from in front of the Gold King Mine Level 7 New Adit portal. Sample No. 1 consisted of soil sampled from various locations along the safety berm.

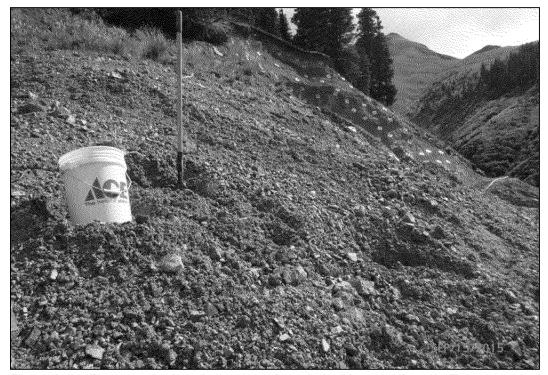
Figure C-2.—Photograph of stockpile where Sample No. 2 was collected. The rock anchors supporting the Gold King Mine Level 7 portal can be seen in the background.
